# RIPARIAN VEGETATION INVENTORY AND FUNCTION ASSESSMENT OF TRIBUTARIES AND MARINE SHORELINE

## NORTHWEST WHATCOM COUNTY

Anchor QEA, LLC  
1423 Third Avenue, Suite 300  
Seattle, Washington 98101

**June 2010**

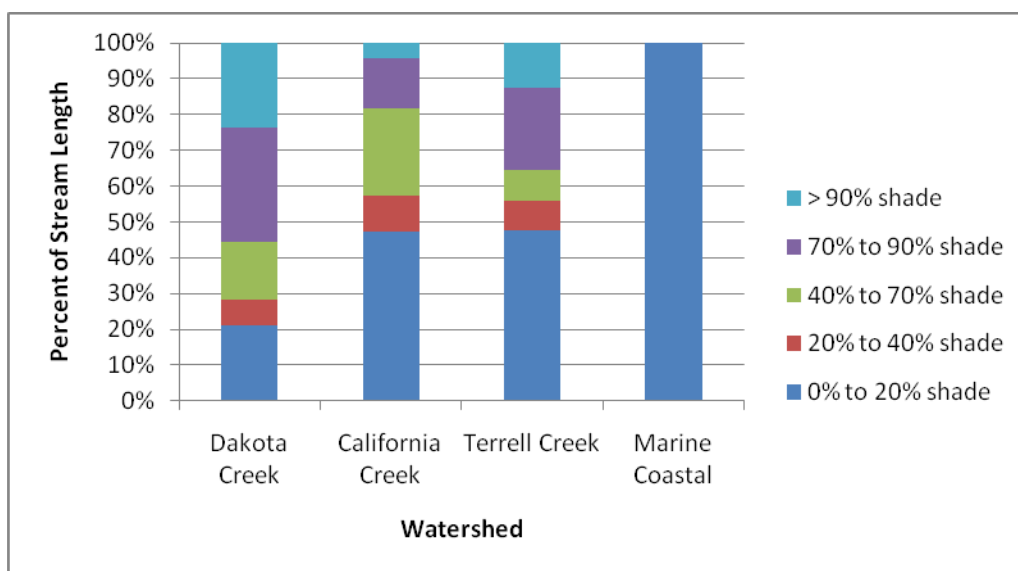
**Figure 2**  
**Percent Shade Cast over Waterbody**

In terms of the percent shade cast over the creeks by the adjacent vegetation, the entire coastal marine shoreline and nearly 50 percent of the California Creek and Terrell Creek watersheds have 0 to 20 percent shade (Table 13, Figure 2, Maps 4 and 5). In Dakota Creek, only 21 percent of the stream length had 0 to 20 percent shade, and the remainder of the watershed had higher amounts of shade. More than 70 percent shade was observed along 56 percent of the Dakota Creek shoreline; in California Creek, this number was 18 percent, and in Terrell Creek, it was 35 percent. It should be noted that some natural shorelines and natural vegetation types do not cast shade; therefore, 100 percent shade is not a natural target for all shorelines. For example, shrub vegetation in a wetland may not cast shade over the creek, depending on stream width.

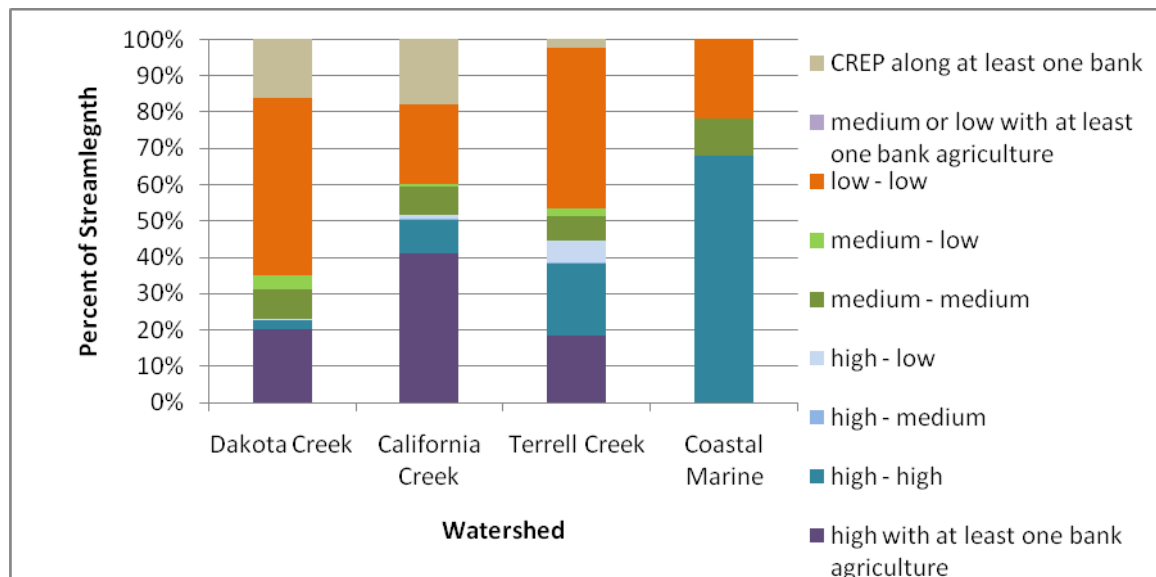
**Figure 3**  
**Percent of Watershed Stream Length in each Large Woody Debris Recruitment Restoration Need Category**

There is a more widespread need for restoration of LWD recruitment potential in California Creek and along the coastal marine shoreline, than in Dakota and Terrell creeks (Table 14, Figure 3, Map 8). In fact, at least one bank was identified as having a high restoration need along 50 percent of the shoreline in California Creek (41 percent [25.7 miles] high need in agriculture areas and 9 percent [5.6 miles] high need). The coastal marine shoreline had 68 percent (16.9 miles) of the shoreline length categorized as high priority for LWD recruitment restoration (Map 9), although as noted above, some of the coastal shorelines likely lack LWD potential due to natural conditions. In Dakota and Terrell creeks, 20 and 18 percent of the stream lengths, respectively, (11.7 and 6.6 miles, respectively) were categorized as high restoration need with at least one bank agriculture.

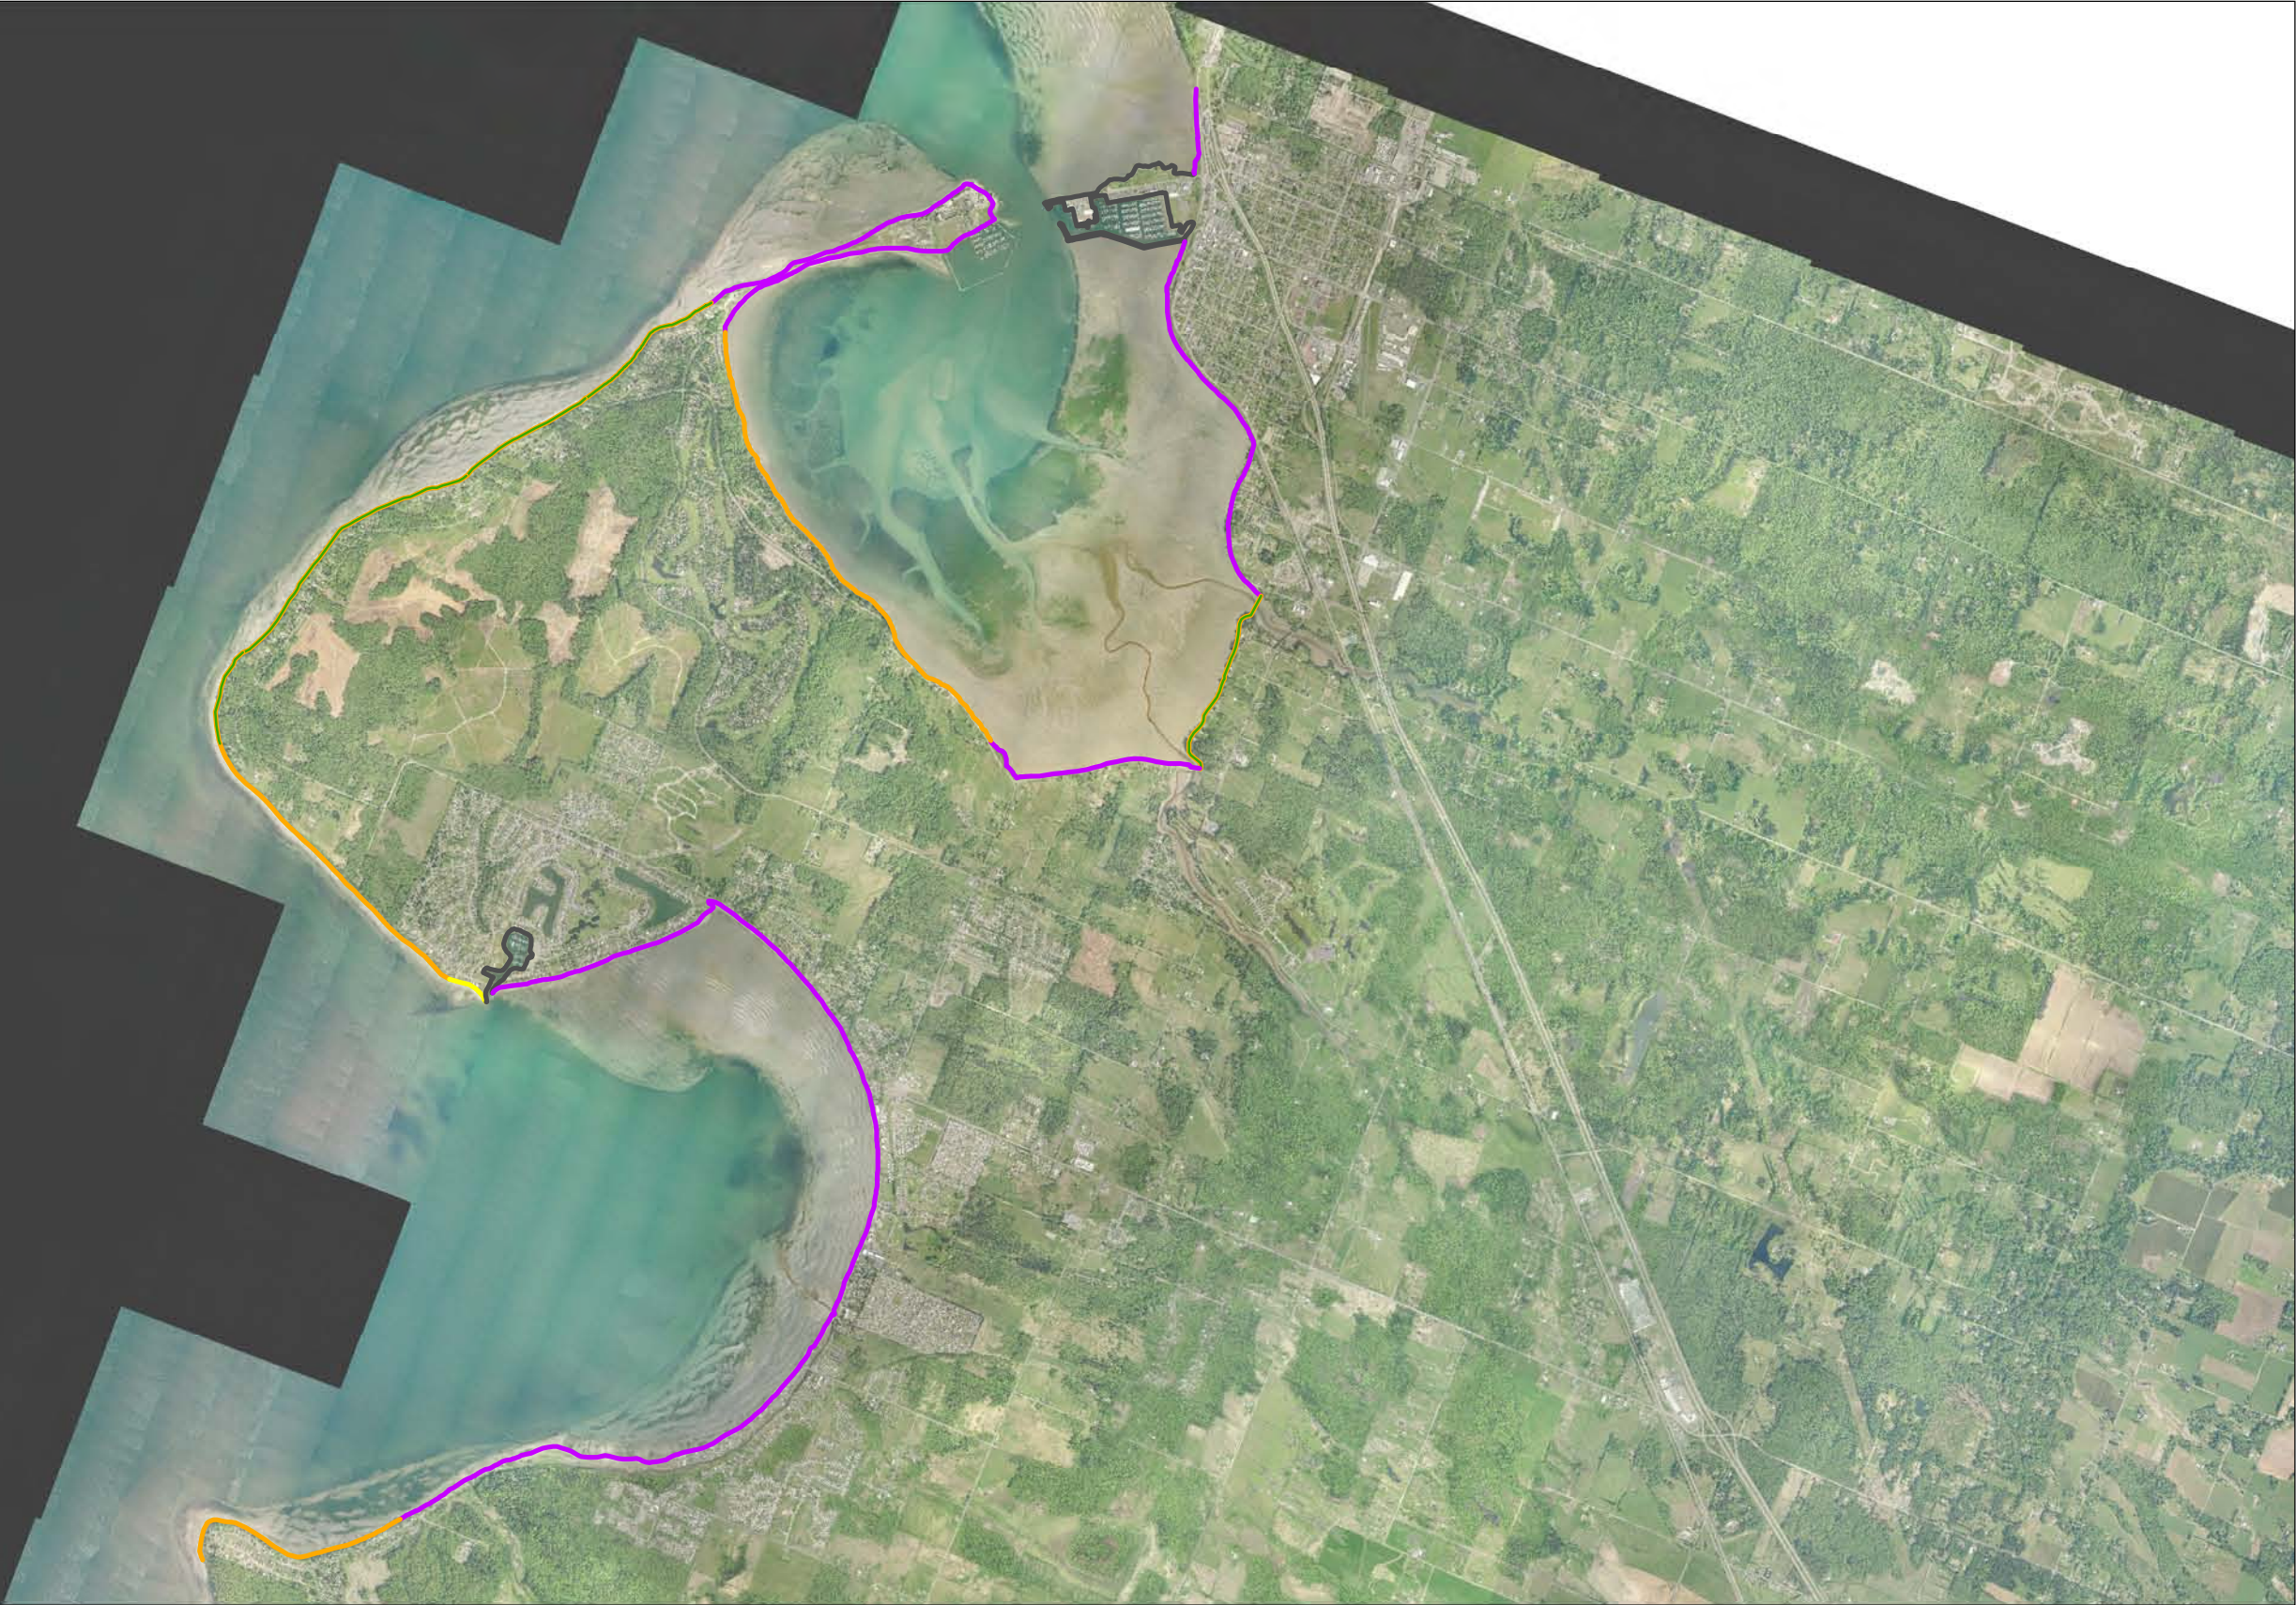
R:\Voss\100148-01\_WhatcomCo\_RiparianAssessment\Maps\2010\_05\Report Maps\Map4-Tributary\_shade.mxd epipkin 05/19/2010 7:32 AM

**LEGEND**  
**Coastal Vegetation Type - (30' Buffer)**

Deciduous  
 Coniferous  
 Mixed  
 Shrub  
 Agricultural  
 Lawn/Landscape  
 Urban

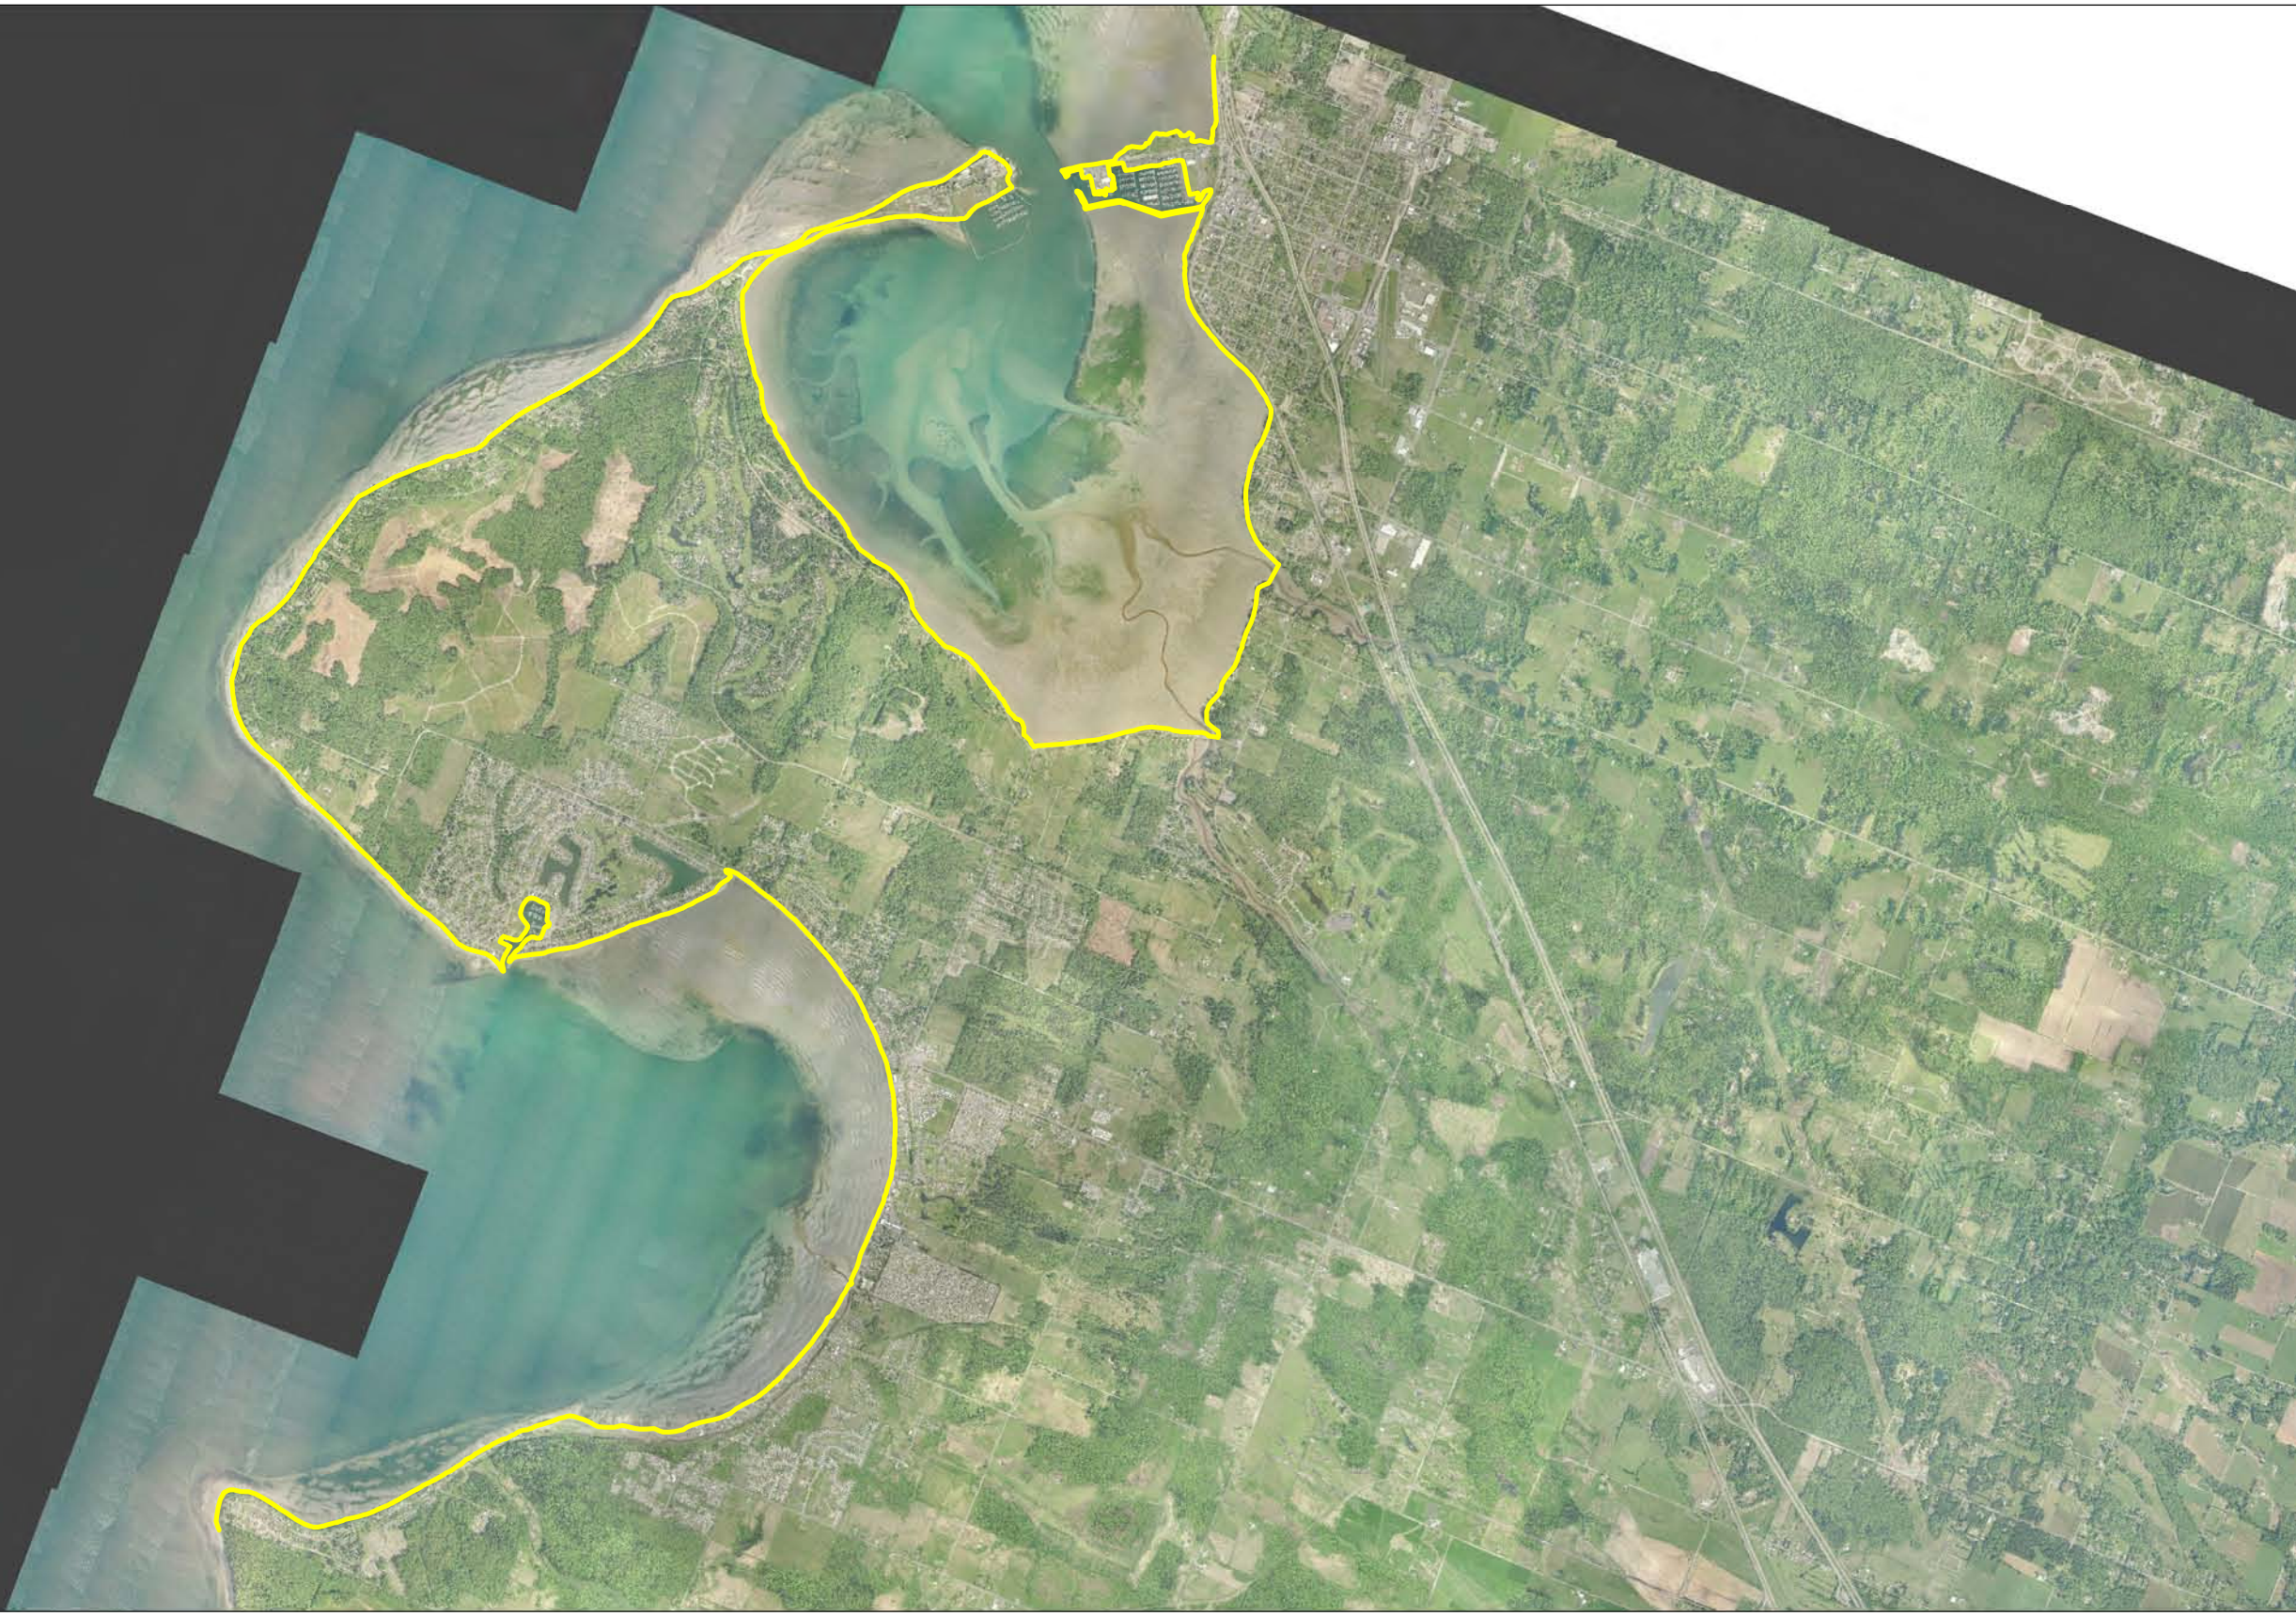
**Coastal Shade Percentage - (30' Buffer)**

0 to 20
20 to 40
40 to 70
70 to 90
>90

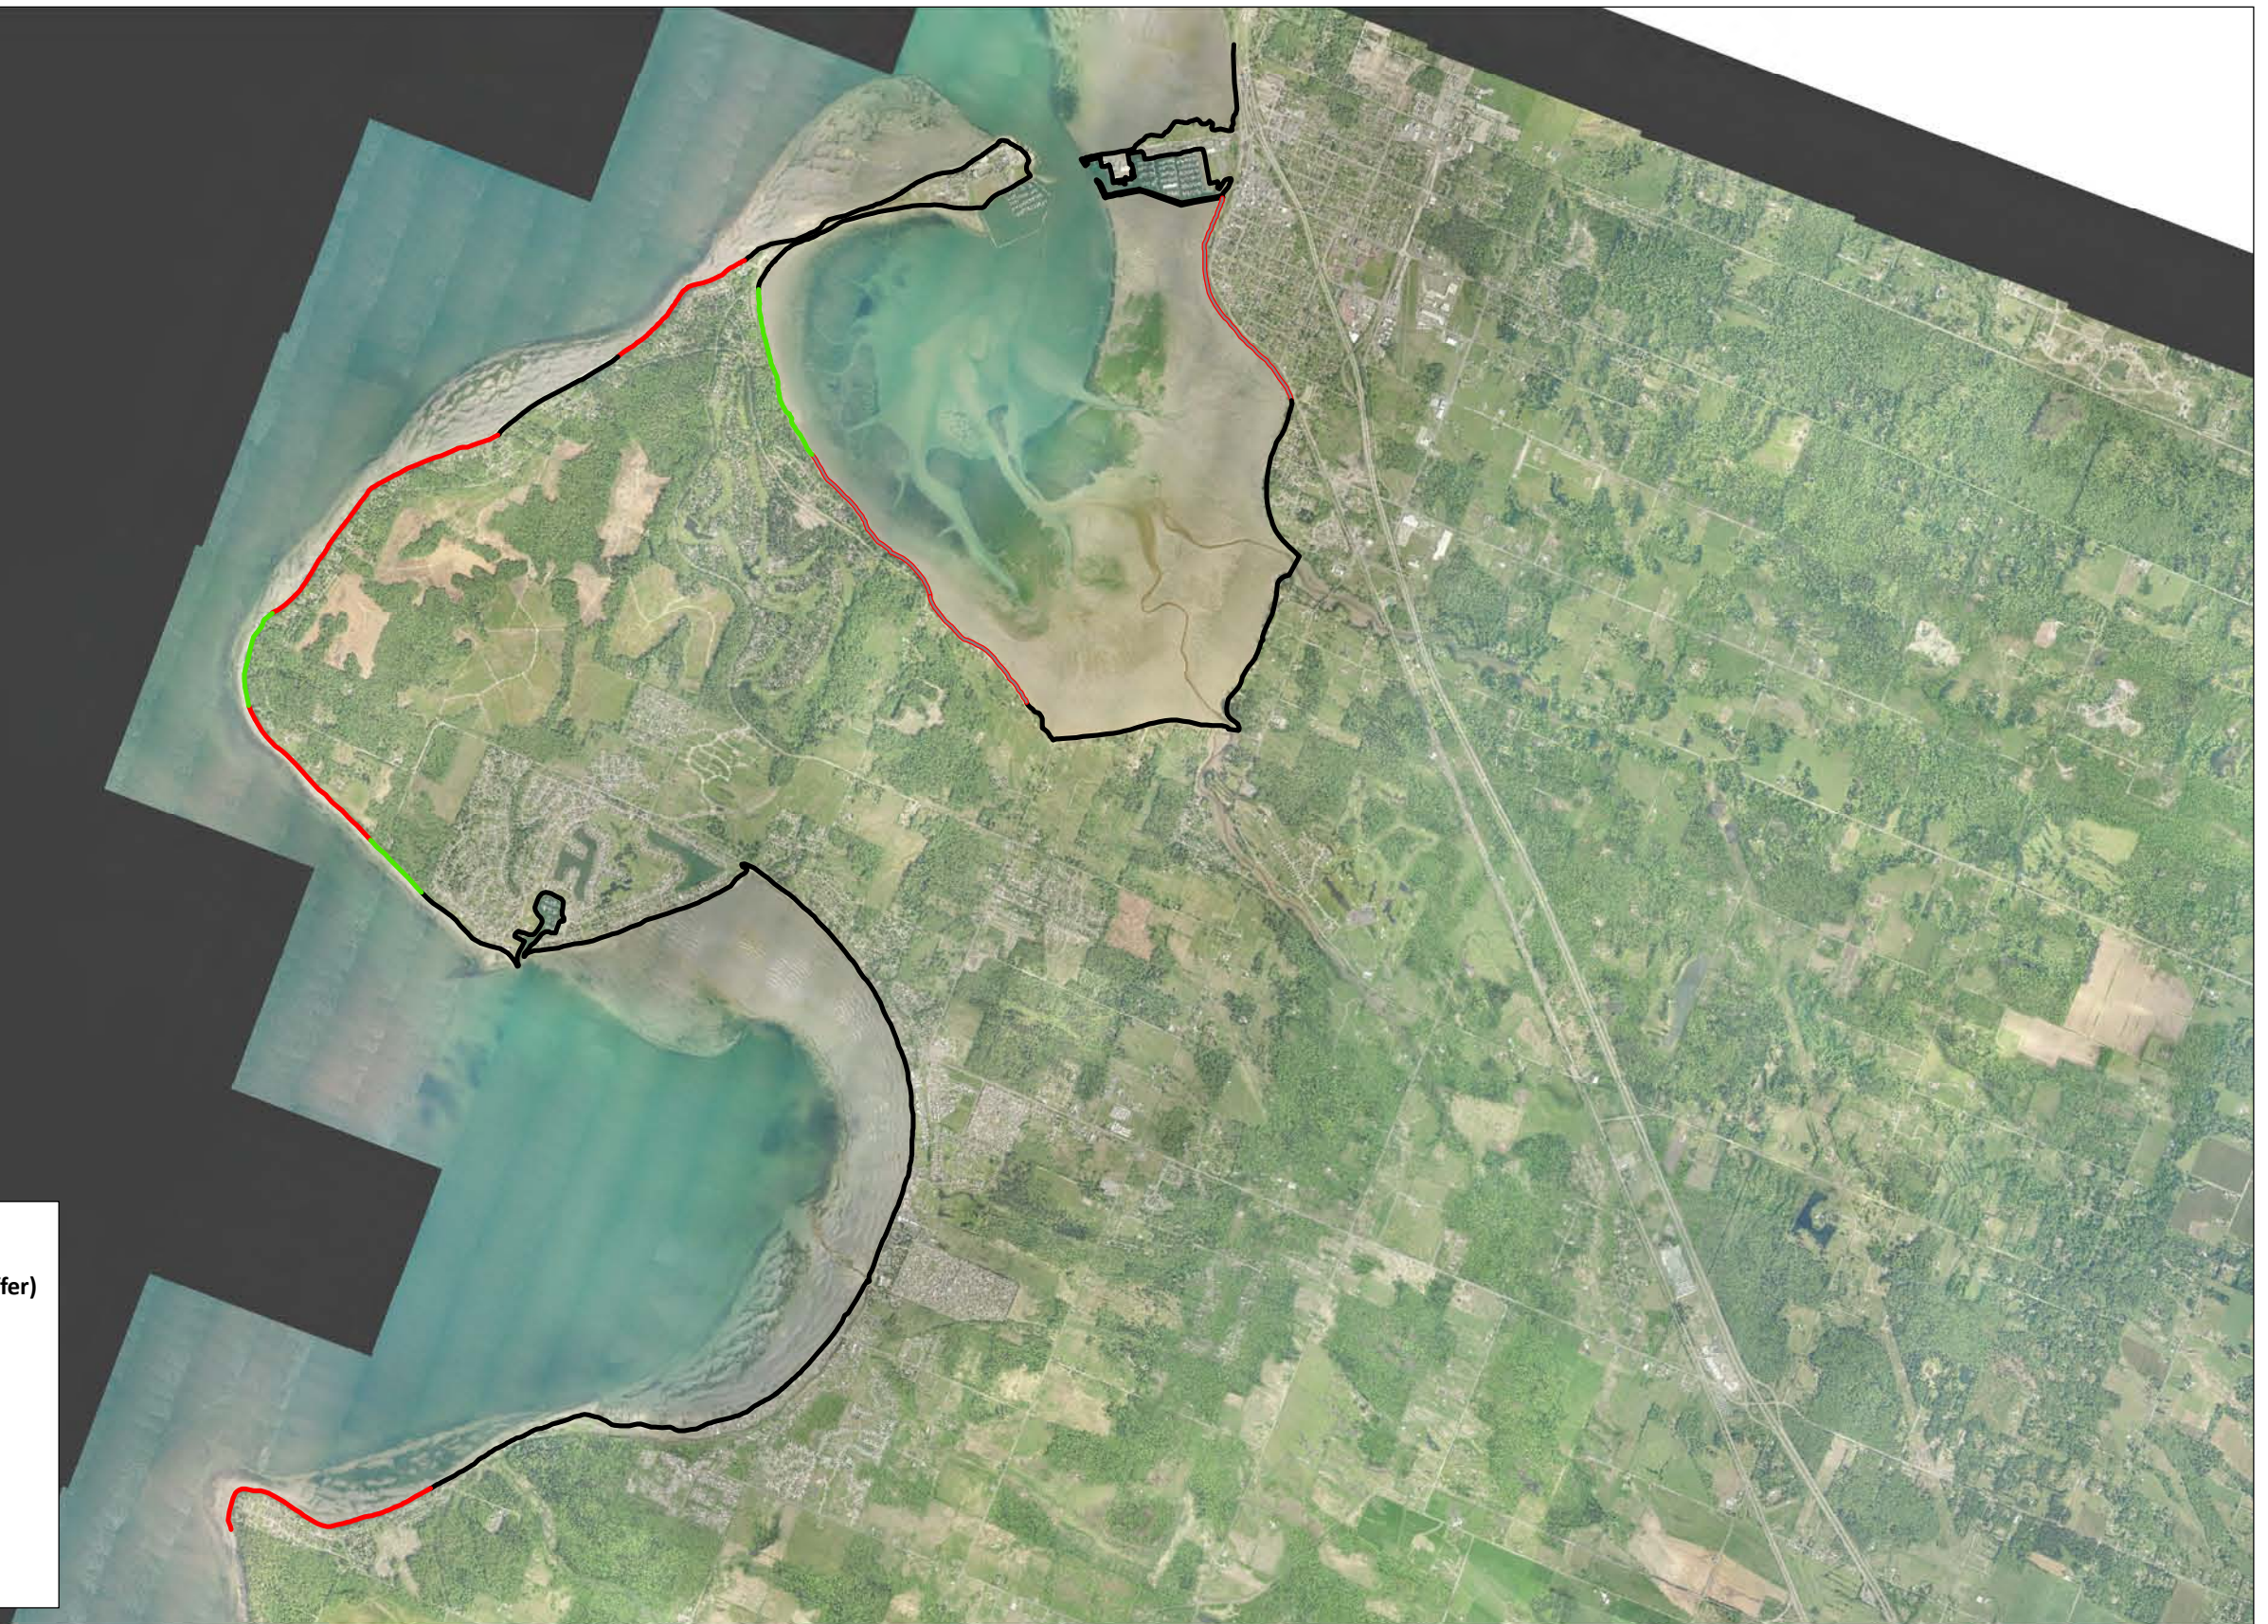
##### Coastal Existing LWD Recruitment Potential - (100' Buffer)

- High
- Medium-Dense
- Medium-Sparse
- Low-Dense
- Low-Sparse
- None
- None-Agriculture

The LWD recruitment potential component provides an indication of the riparian buffer contribution to the instream habitat and channel complexity conditions of the tributary. Existing LWD recruitment potential was evaluated in a manner similar to the Washington Department of Natural Resources (WDNR) Watershed Analysis Manual as applied in the Nooksack River Basin by Coe (2001). This approach results in a qualitative indicator of the potential for trees to fall into and become lodged in the stream. One refinement to this method was to differentiate between areas with dense or sparse vegetation in the medium and low categories. Existing LWD recruitment potential was assigned to each bank of each

reach based on the riparian vegetation conditions in the 100-foot buffer. The 100-foot buffer was used instead of the 30-foot buffer because it provides a better indication of the long-term potential for LWD, whereas the 30-foot buffer may be a single tree wide, which would leave no replacement tree vegetation when that tree falls. Dense and sparse vegetation were grouped into different categories because the categories lead to different restoration priorities.

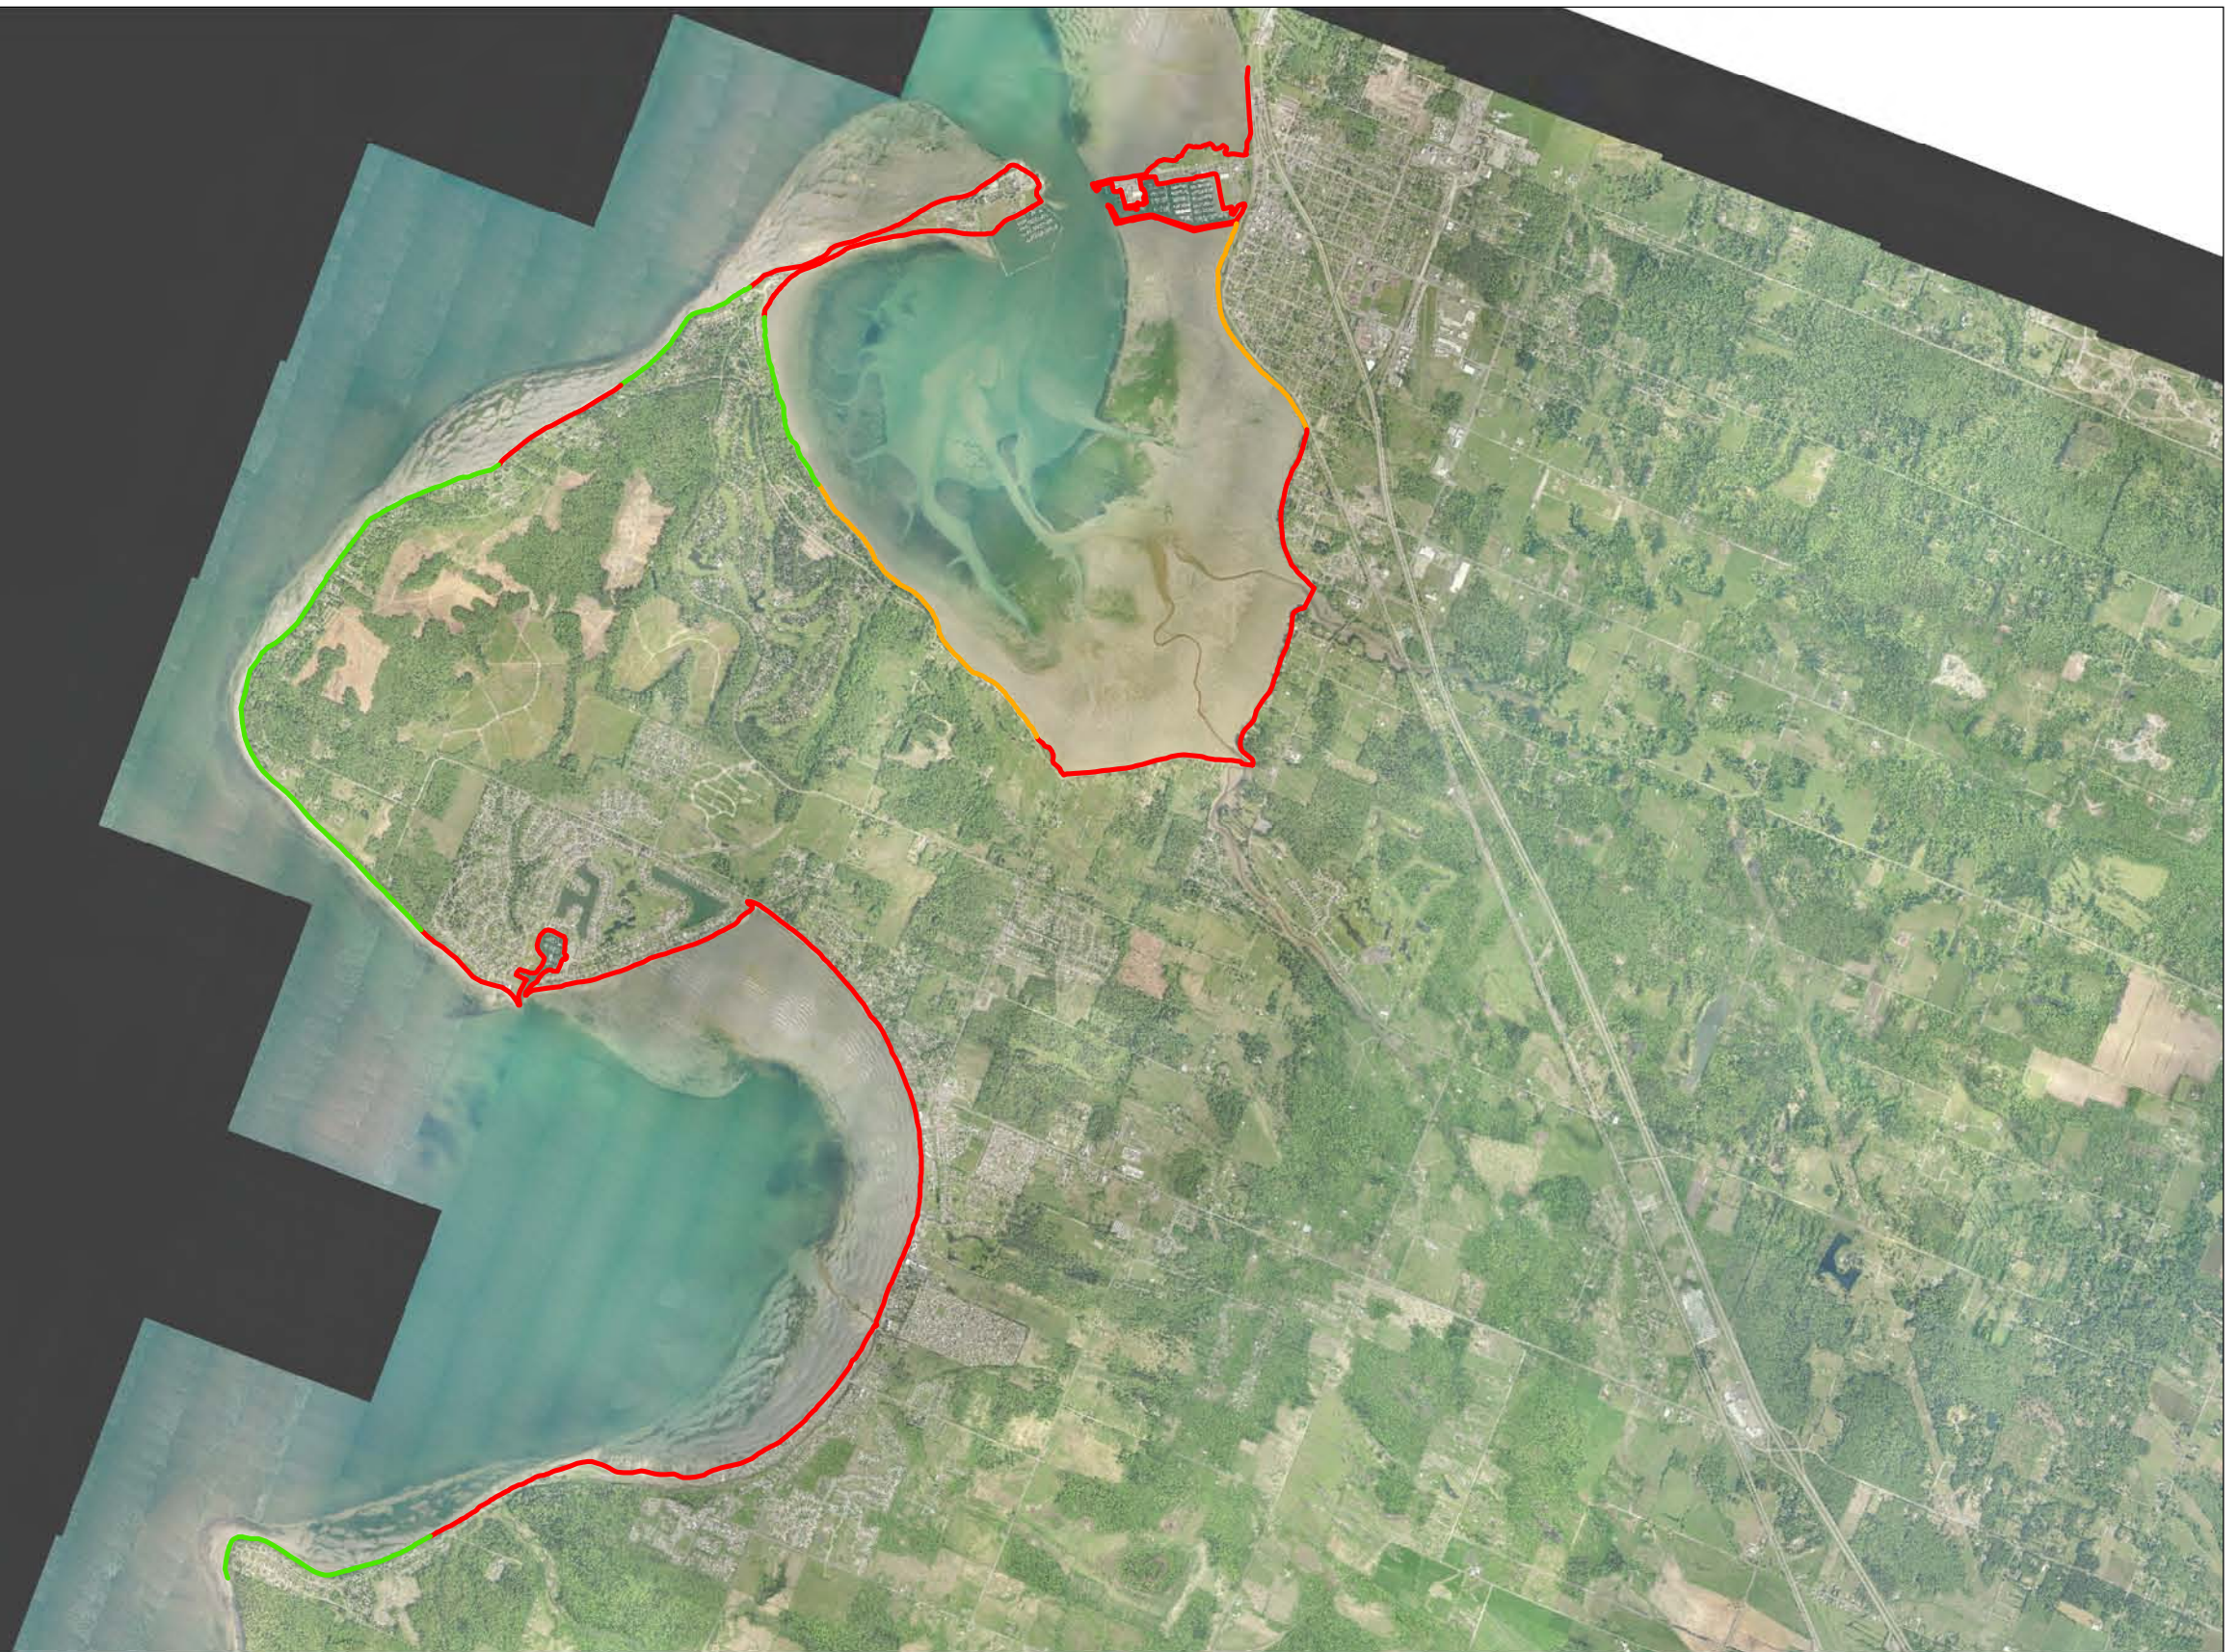
##### Coastal LWD Restoration Need - Left Bank (100' Buffer)

- High
- High-Agriculture
- Medium
- Low
- High-Agriculture-CREP Site

Restoration need was assigned based on the existing conditions, such that low existing potential led to a high restoration potential and vice versa. Reaches with medium or low existing LWD potential but dense tree vegetation were assigned to the low restoration potential category because either the LWD recruitment potential will emerge as the trees continue to grow or the need to add conifers to a stand of dense deciduous trees is less than other restoration needs. The existing and restoration need category assignments for each bank of each reach used the assignments shown in Table 5.

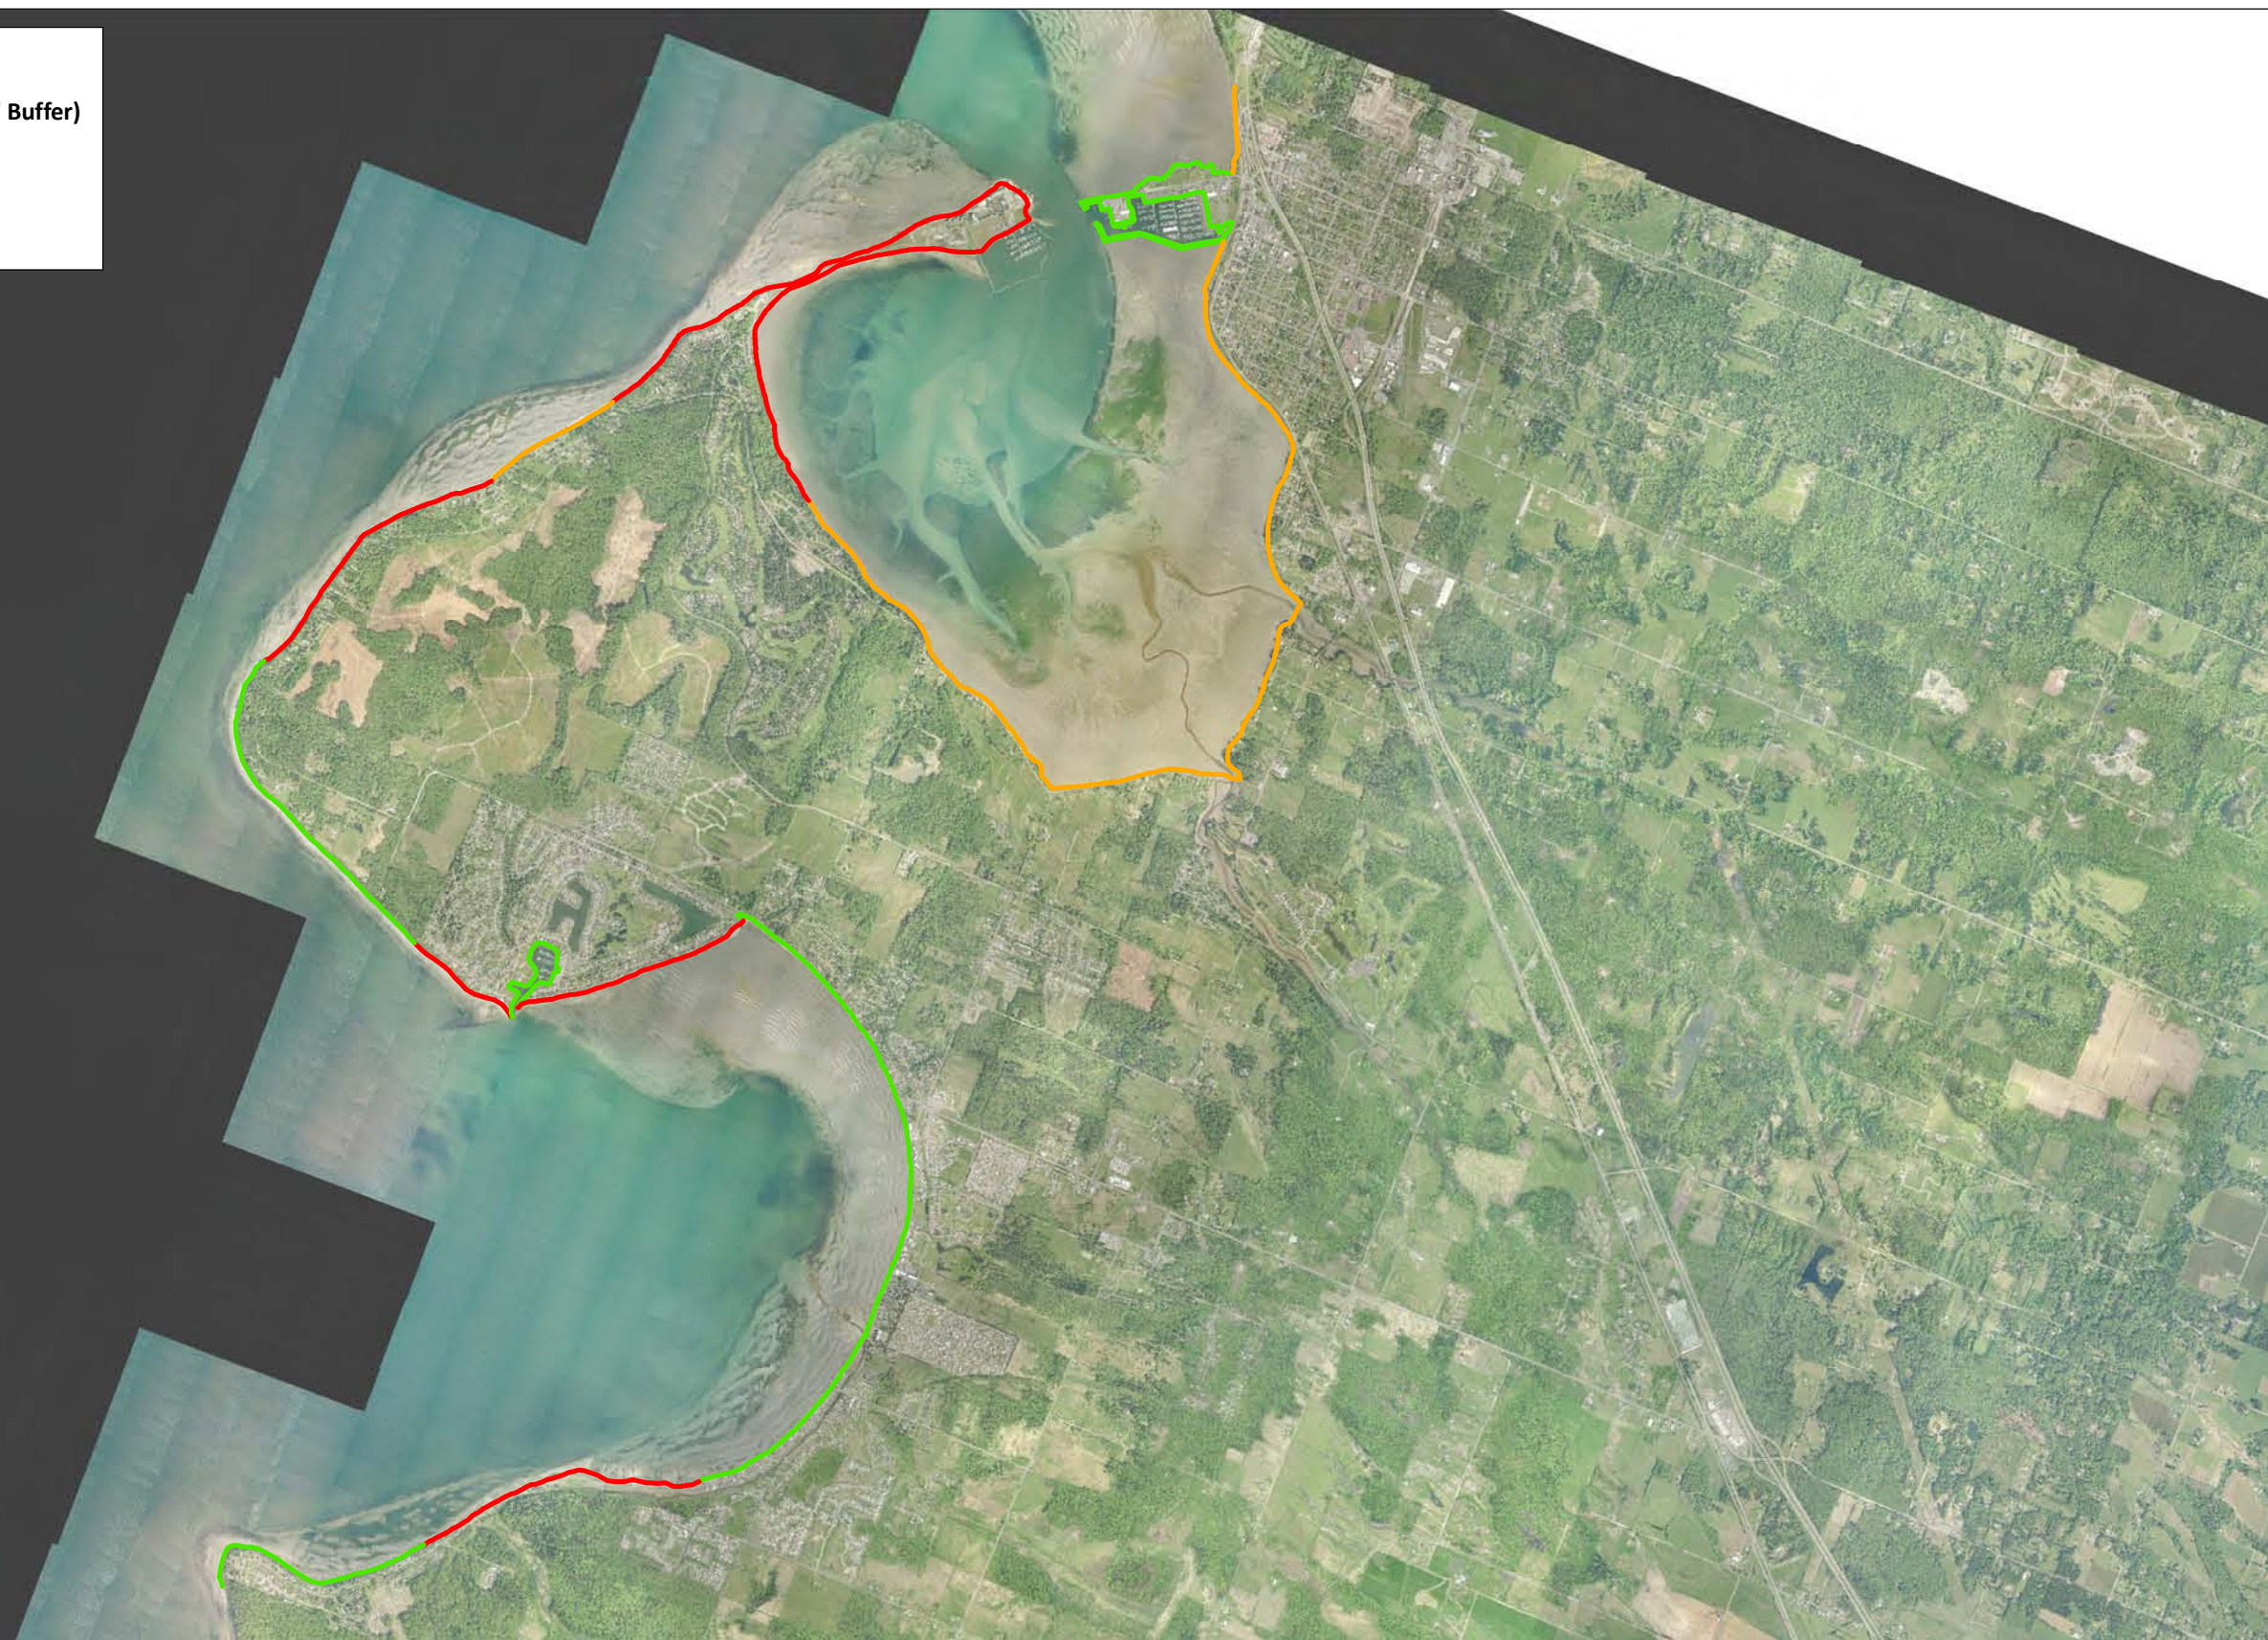
##### Coastal Wildlife Connectivity Restoration Need - (100' Buffer)

- High
- Medium
- Low

provide wildlife corridor functions was considered to be any of the tree categories with dense vegetation rather than sparse vegetation. Table 6 describes the category assignments made to the 30-foot and the 100-foot buffers on each side of the creek or along the coastal marine shoreline. Table 7 describes the combination of the 30-foot and 100-foot buffer vegetation conditions for an overall categorization of wildlife corridor connectivity in the reach. As described above, this categorization emphasizes the 100-foot buffer conditions over the 30-foot buffer conditions.
