# RIPARIAN VEGETATION INVENTORY AND FUNCTION ASSESSMENT OF TRIBUTARIES AND MARINE SHORELINE

## NORTHWEST WHATCOM COUNTY

Anchor QEA, LLC  
1423 Third Avenue, Suite 300  
Seattle, Washington 98101

**June 2010**

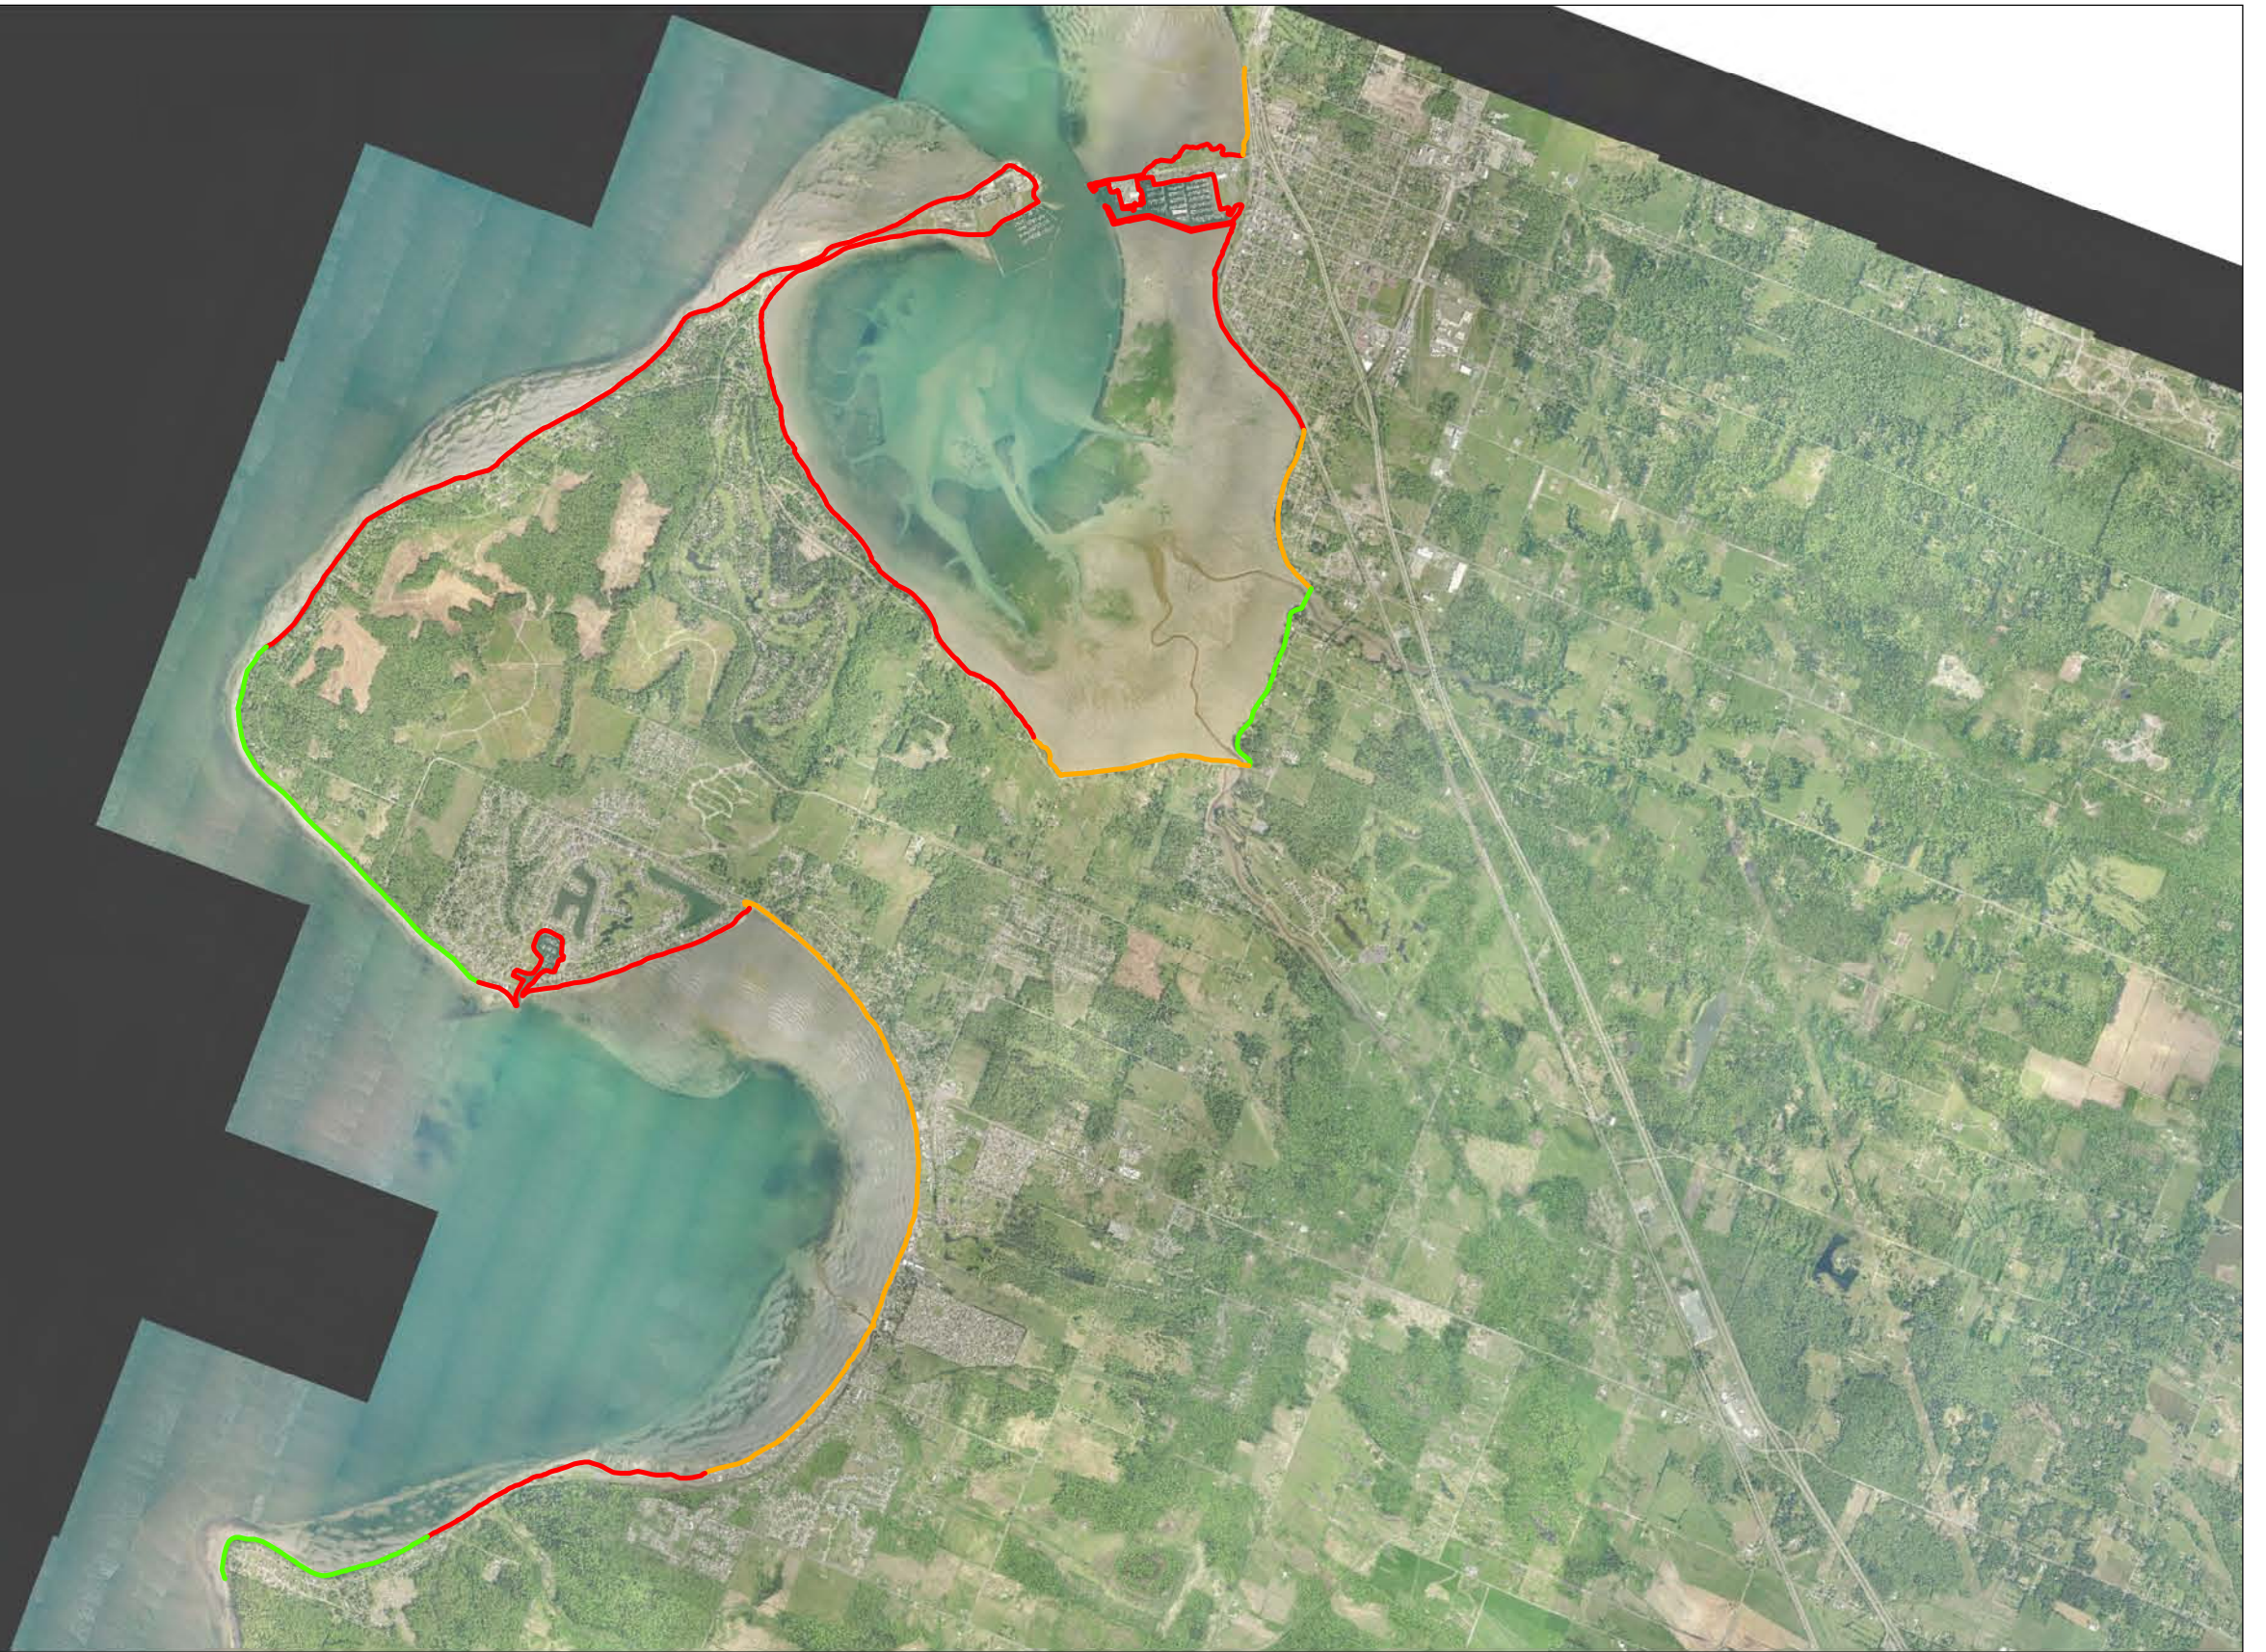
##### Coastal Water Quality Restoration Need - (30' Buffer)

- High
- Medium
- Low

Contributions of the riparian vegetation to unimpaired water quality were assessed based on vegetation type, percent shade, and vegetation density. Table 8 presents the system used to categorize the existing conditions and restoration need.
