# RIPARIAN VEGETATION INVENTORY AND FUNCTION ASSESSMENT OF TRIBUTARIES AND MARINE SHORELINE

## SOUTHWEST WHATCOM COUNTY

**October 2012**

# PHASE 2 RIPARIAN VEGETATION INVENTORY AND FUNCTION ASSESSMENT OF TRIBUTARIES AND MARINE SHORELINE SOUTHWEST WHATCOM COUNTY

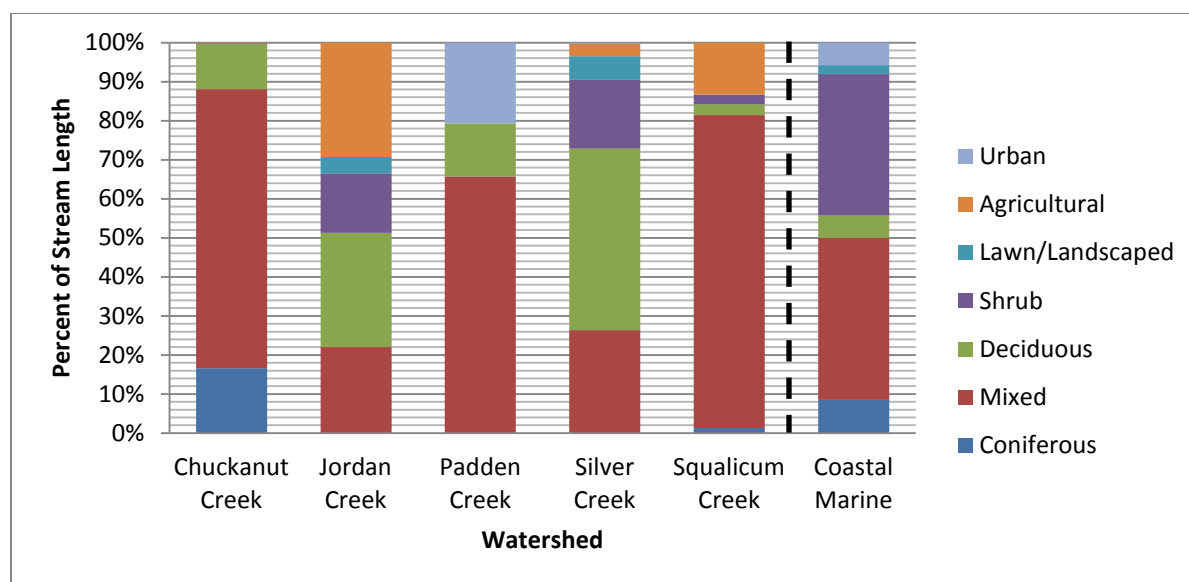
**Figure 1**  
**Percent of Stream Length Composed of Each Vegetation Type**

The differences between tributaries in the extent of “agriculture” riparian vegetation appear to reflect the degree to which vegetated riparian buffers are present in the agricultural areas of each watershed. Based on land cover data from the National Oceanic and Atmospheric Administration’s (NOAA) 2006 Coastal Change Analysis Program, the tributary corridors in Jordan, Silver, and Squalicum creeks are 46, 9, and 20 percent agriculture<sup>1</sup>, respectively; whereas, Chuckanut and Padden creeks are 0 percent agriculture. This information appears to indicate that the establishment of vegetated riparian buffers is more widespread in Chuckanut and Padden creeks than in Jordan, Silver, and Squalicum creeks.

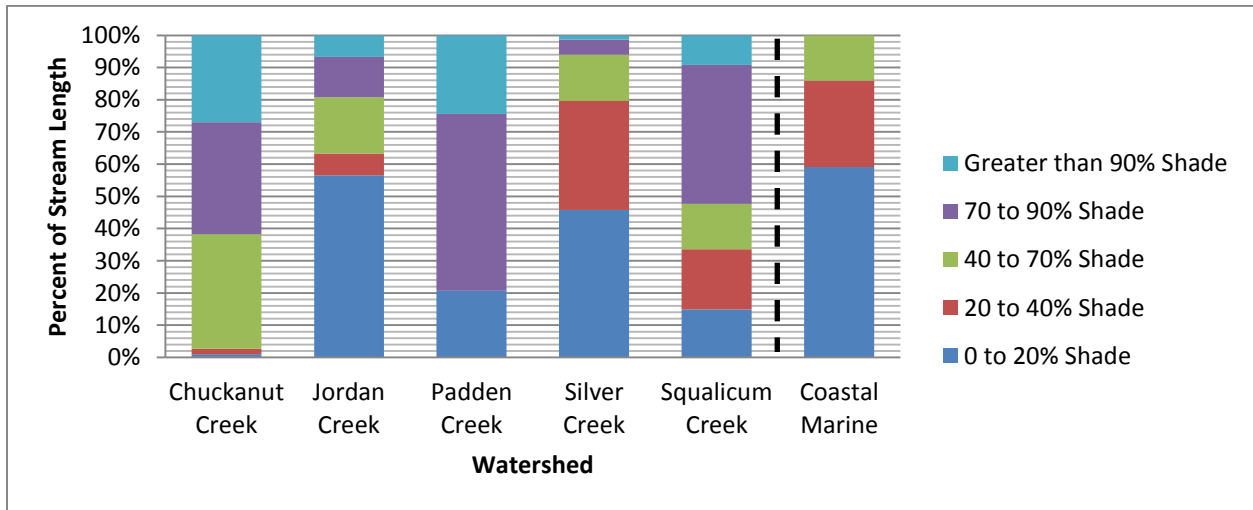
**Figure 2**  
**Percent Shade Cast over Waterbody**

In terms of the percent shade cast over the creeks by the adjacent vegetation, nearly 50 percent of the coastal marine, Jordan Creek, and Silver Creek shorelines have 0 to 20 percent shade (Table 14, Figure 2, Maps 4 and 5). In Padden Creek, only 23 percent of the stream length had 0 to 20 percent shade, and the remainder of the creeks had higher amounts of shade. More than 70 percent shade was observed along 61 percent of the Chuckanut Creek shoreline; in Squalicum Creek, this number was 53 percent, and in Padden Creek, it was 77 percent. It should be noted that some natural shorelines and natural vegetation types do not cast shade; therefore, 100 percent shade is not a natural target for all shorelines. For example, shrub vegetation in a wetland may not cast shade over the creek, depending on stream width.

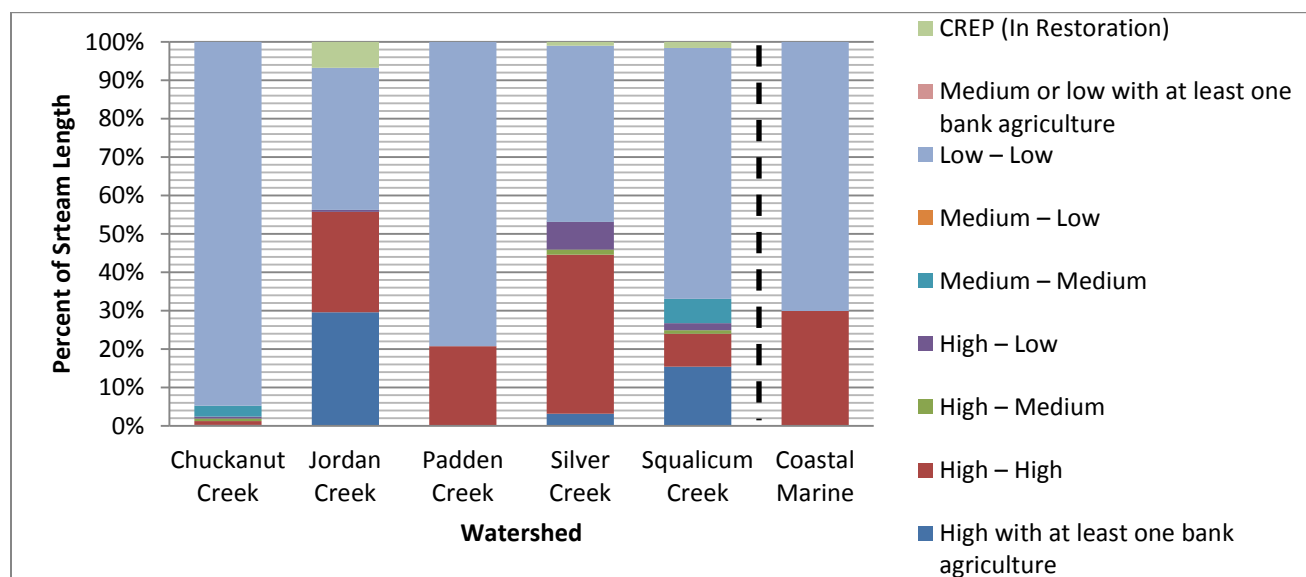
**Figure 3**  
**Percent of Watershed Stream Length in Each Large Woody Debris Recruitment Restoration Need Category**

The shoreline length for which existing LWD recruitment potential was characterized as high along at least one bank of the shoreline ranged from 6 percent (1.1 miles) along Jordan Creek to 83 percent (16.0 miles) in Chuckanut Creek (Maps 7 and 8), based on existing vegetation conditions in the watersheds. Padden Creek and Squalicum Creek were intermediate, with 66 and 61 percent, respectively (0.8 and 14.5 miles, respectively), and were characterized as high function for existing LWD recruitment potential.

In the creeks, restoration potential was categorized based on the conditions observed on both banks. In this way, the restoration potential categories described two bank conditions (e.g., high – high). An exception to this categorization system was stream reaches, with agriculture along at least one bank categorized as high priority for restoration. Due to the different restoration opportunities and constraints associated with agriculture, these stream reaches were categorized separately as “high with at least one bank agriculture.” Another exception was the separate categorization of reaches with land in the CREP program as "In Restoration."

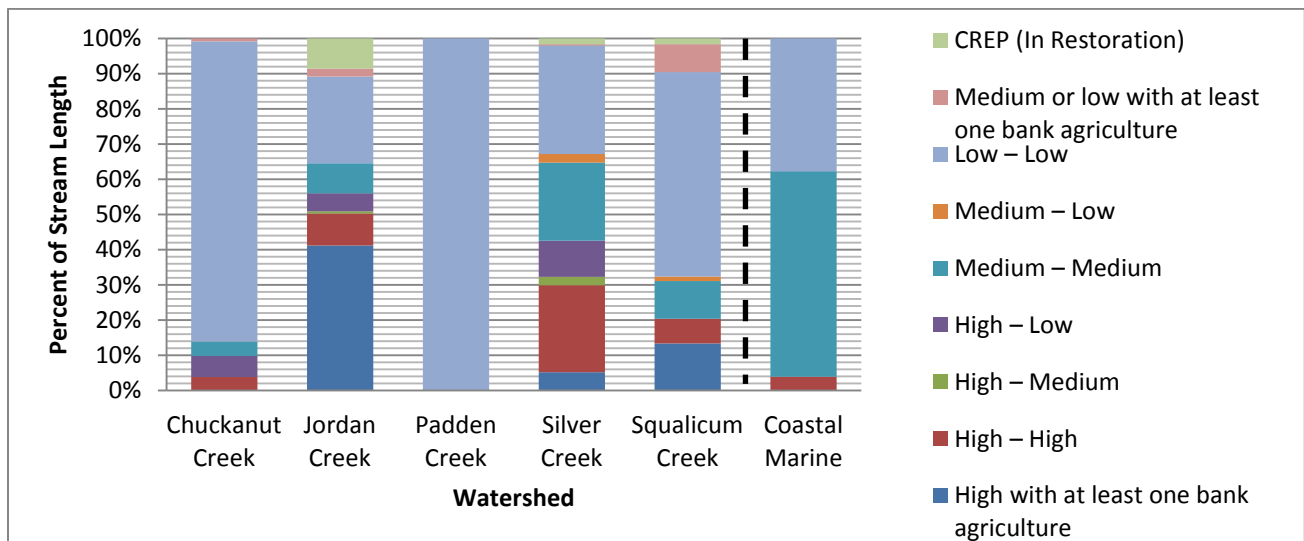
**Figure 4**  
**Percent of Watershed Stream Length in Each Wildlife Corridor Restoration Need Category**

Wildlife corridor conditions were categorized as providing high function in Chuckanut and Padden creeks. In Chuckanut Creek, 96 percent (18.3 miles) of the stream length was categorized as having at least one bank with high function for wildlife corridor conditions. In Padden Creek, 79 percent (1.0 miles) was categorized as having at least one bank with high function for wildlife corridor conditions. Lower percentages of high function were observed in Jordan, Silver, and Squalicum creeks and along the coastal marine areas, where 41, 54, 68, and 19 percent, respectively (7.3, 15.8, 16.4, and 19.0 miles) of high existing function for wildlife corridor conditions occurred (Maps 11 and 12). Map 13 shows the location of the reaches where restoration to fill wildlife corridor gaps would create the longest continuous reaches with suitable habitat for wildlife connectivity.

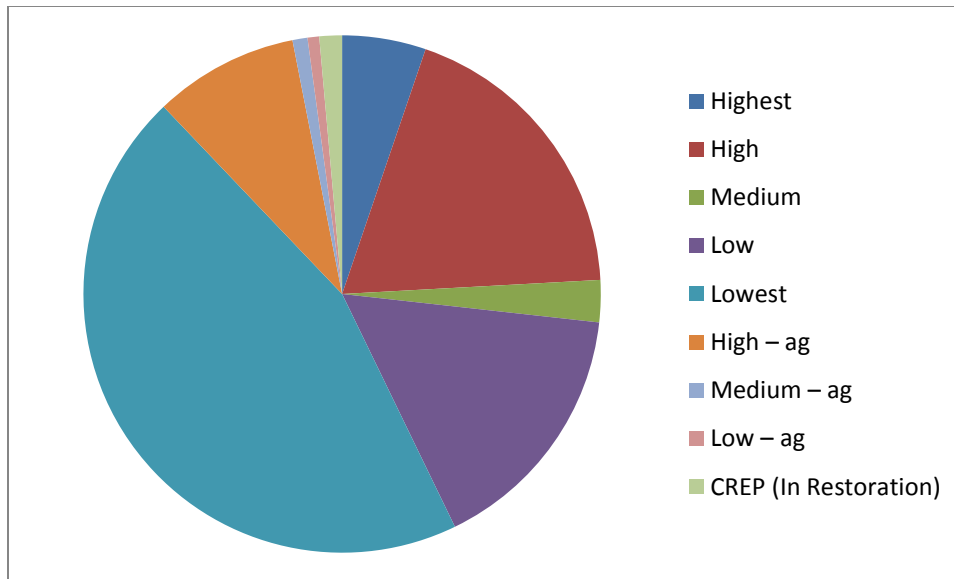
**Figure 6**  
**Combined Restoration Need Category Proportions in the Project Area**

Across the entire tributary project area, 87 percent (79 miles) of the shoreline did not have agriculture or CREP activities along the stream. Agriculture occurred on at least one bank for 10 percent (9.8 miles) of the shoreline. A total of 13 percent (12.25 miles) of the shoreline was assigned to either the highest or the high combined restoration need categories (i.e., aggregate restoration need for LWD, water quality, and wildlife connectivity) and had agriculture along at least one bank (Figure 6). A total of 48 percent (43.6 miles) of the tributary project area was assigned to the lowest restoration need category. A total of 36 percent (9.4 miles) of the coastal marine project area was assigned the lowest restoration need category (this includes only those reaches designated to be conducive to natural riparian function based on shoretype landform).

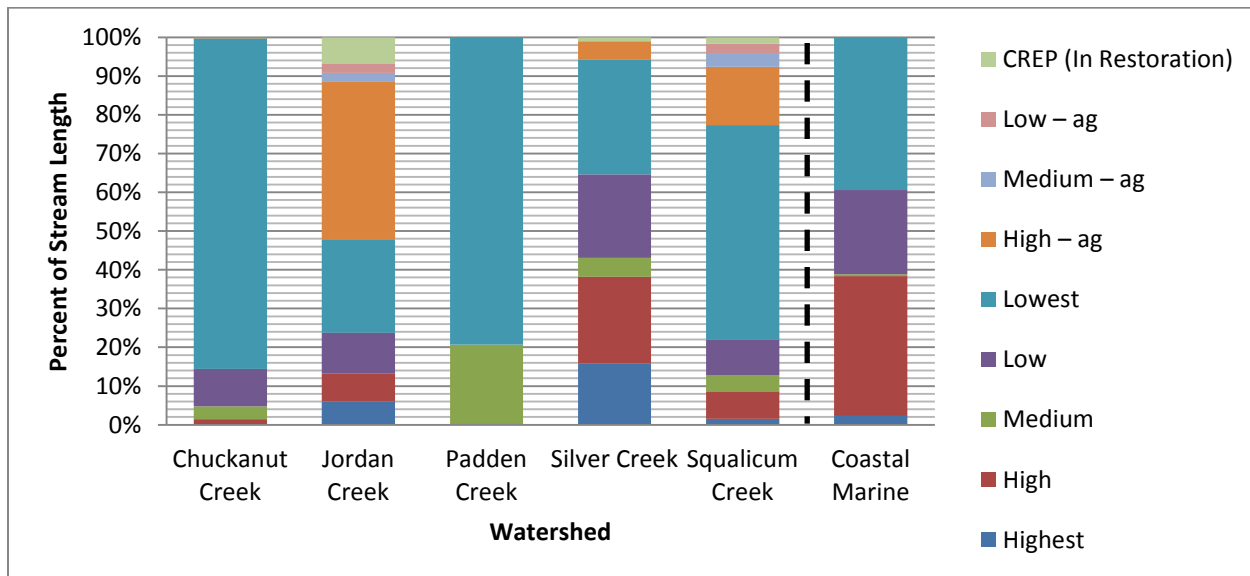
**Figure 7**  
**Percent of Watershed Stream Length in Each Combined Restoration Need Category**

In Chuckanut, Padden, Silver, and Squalicum Creeks, the largest percentages of stream length were in the lowest combined restoration category (88, 77, 35, and 63 percent, respectively) (Table 18 and Figure 7). In Jordan Creek, high restoration need with at least one bank agriculture was the most widespread restoration category (32 percent of stream length). Along the marine coast, the high need category comprised the longest percentage of shoreline length (65 percent).
