Nooksack River Instream Project Effectiveness

April 2020

Contributing Authors: Michael Maudlin, Nooksack Tribe; Alex Levell and Nathan Rice, Lummi Nation

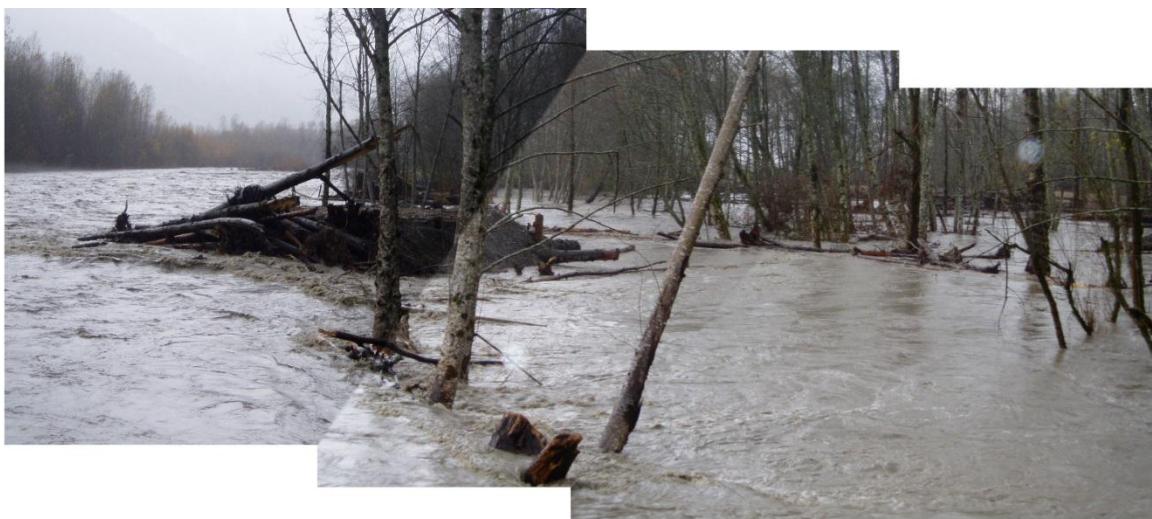
Figure 94: Looking downstream at Logjam #4 in the floodplain during the November 6, 2006 flood.

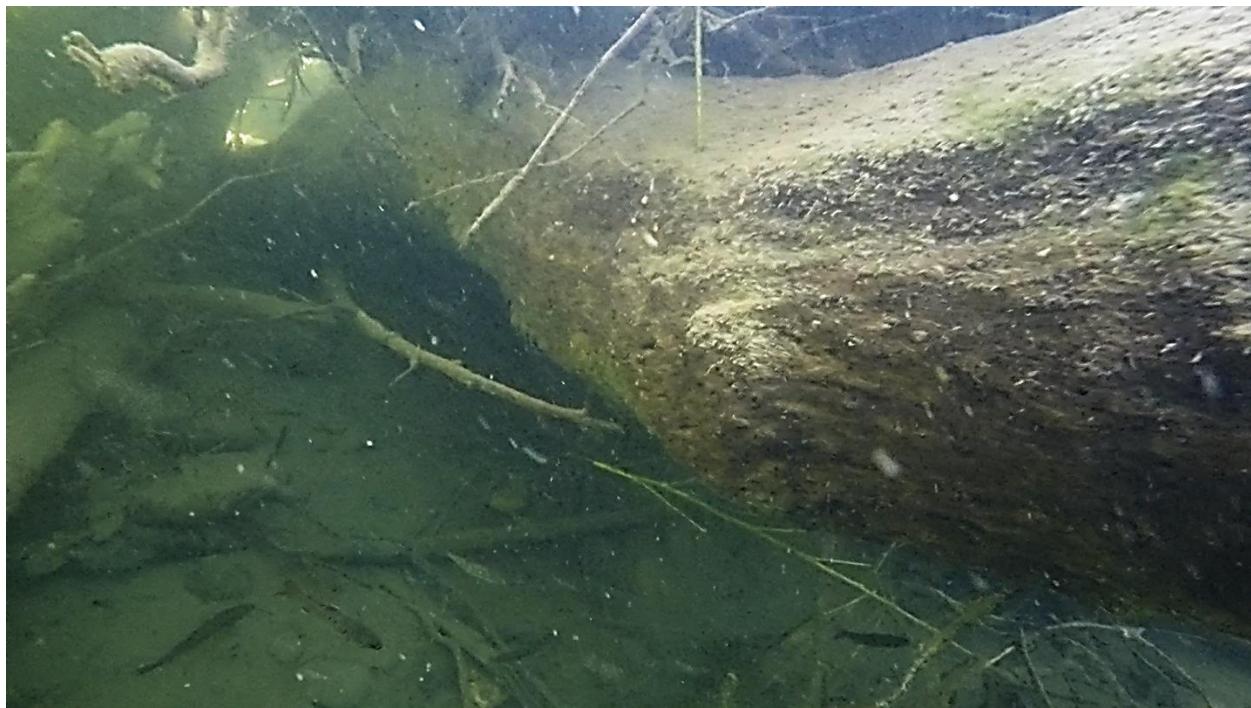
Figure 103: Fish present in the DSHutch 1 refuge area.

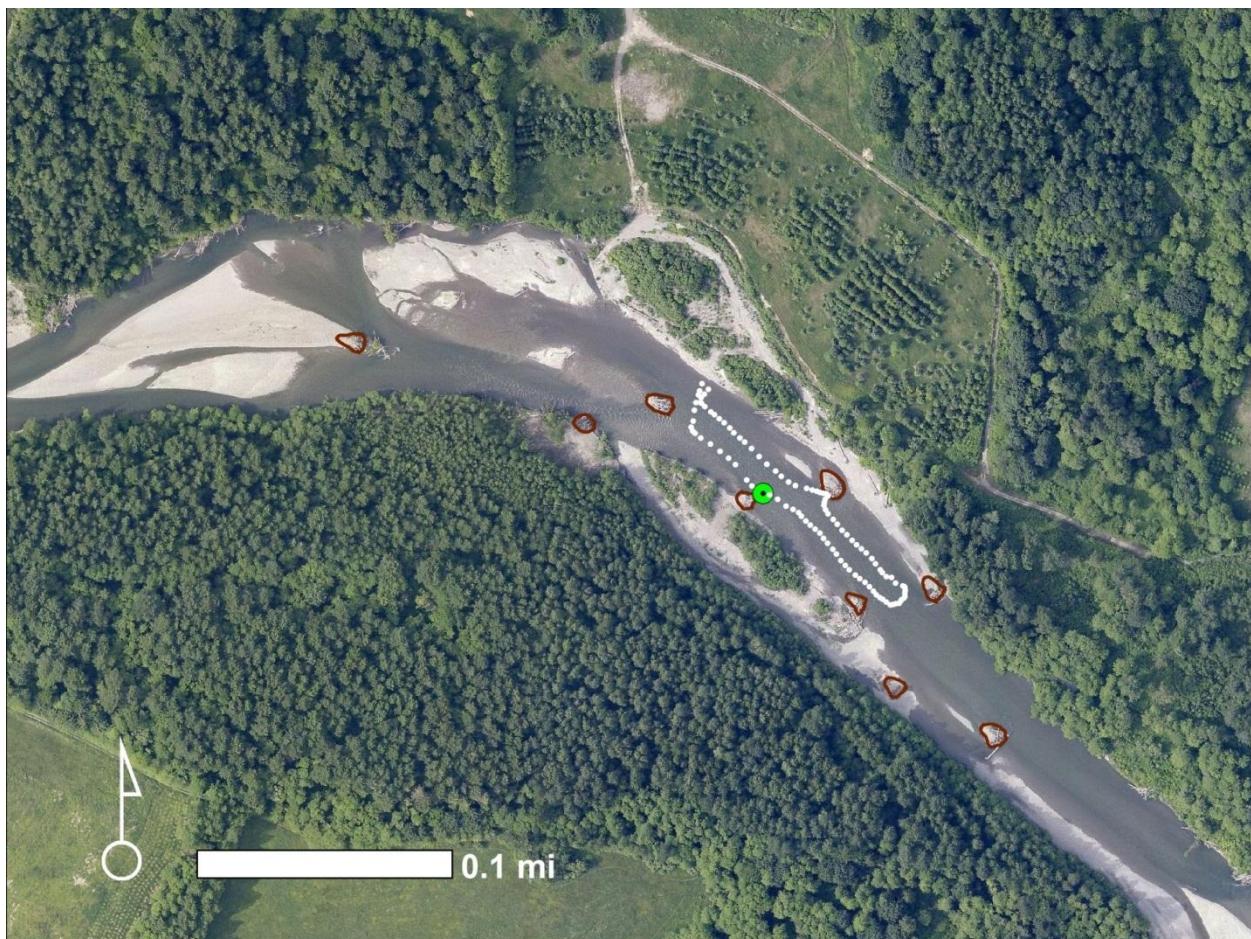
Figure 105: Thermal profile of the Downstream of Hutchinson Project in August of 2013. Note the thermal anomaly at ~320m showing ~2°C temperature difference during the warm part of the day (Gendaszek 2014).
